NAVY EXPERIMENTAL DIVING UNIT
TECHNICAL REPORT NO. 5-99

EVALUATION OF EMERGENCY EVACUATION
HYPERBARIC STRETCHERS (EEHS)

SEPTEMBER 1999

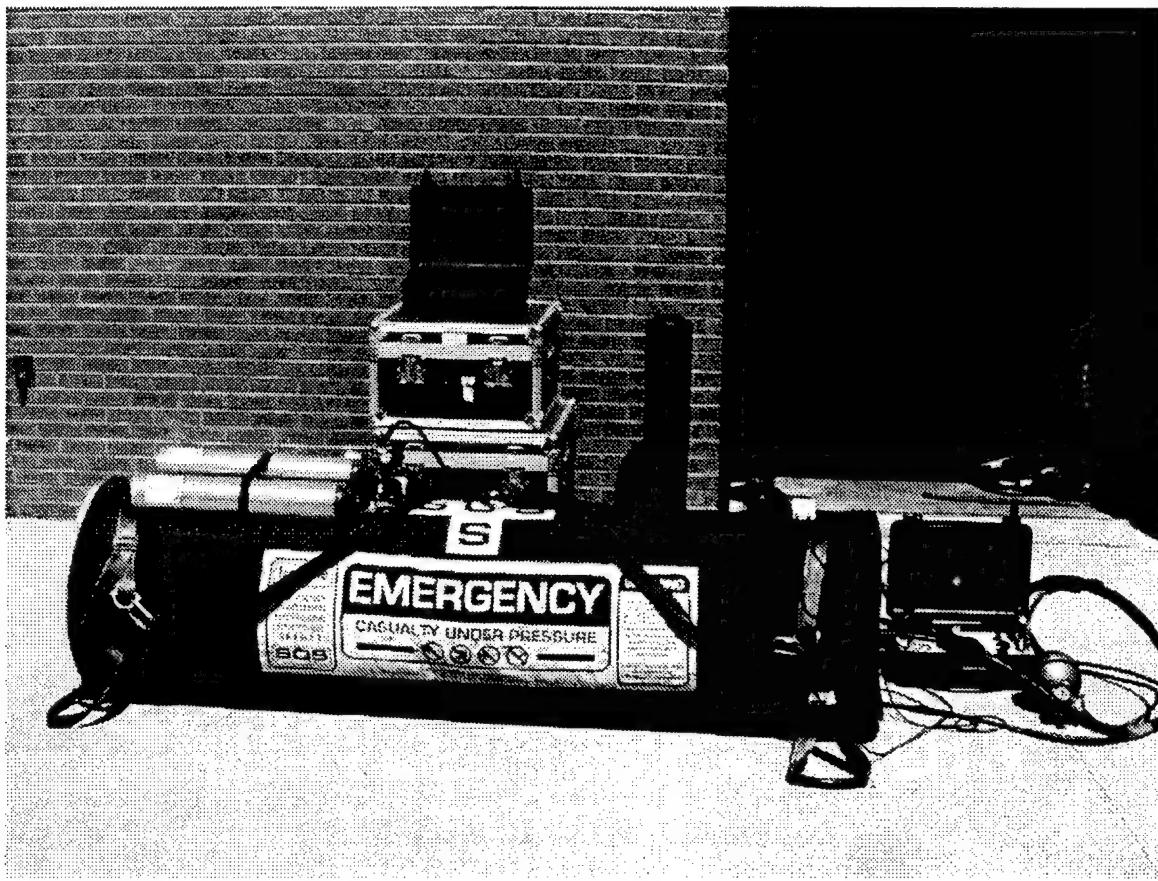
ILLUSTRATION A-1. SOS HYPERLITE EEHS SYSTEM.

- Hyperlite's medical lock is small, but functional. It is simple and easy to operate. It does not obstruct the view of the patient. The only problem noted was that it

could be inadvertently left open during assembly, causing a leak during pressurization. When this occurs, it is obvious and easy to correct quickly.

- On the Hyperlite, hoses enter at the center of the end plates in a long axis orientation. They are not subject to damage if the unit rolls or must pass through a narrow opening during transport.

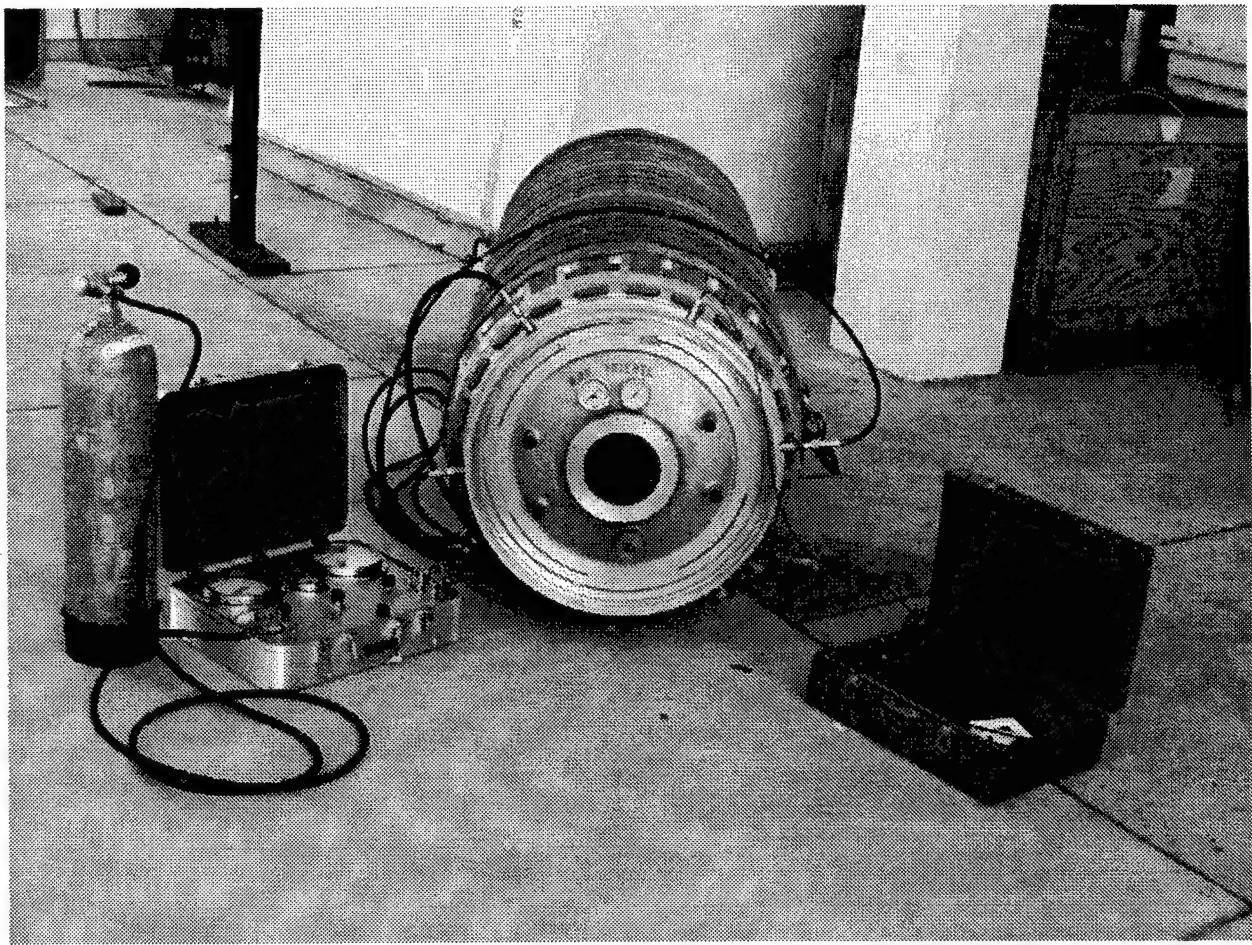
ILLUSTRATION A-2. GSE FLEXIBLE HYPERBARIC EEHS SYSTEM

- On the GSE, hoses enter the end plate rim in the cross sectional axis, as a spoke would enter a hub. They are subject to damage, even dislodgment, if the unit is rolled. They protrude in such a way that they would interfere with transport through a narrow opening.

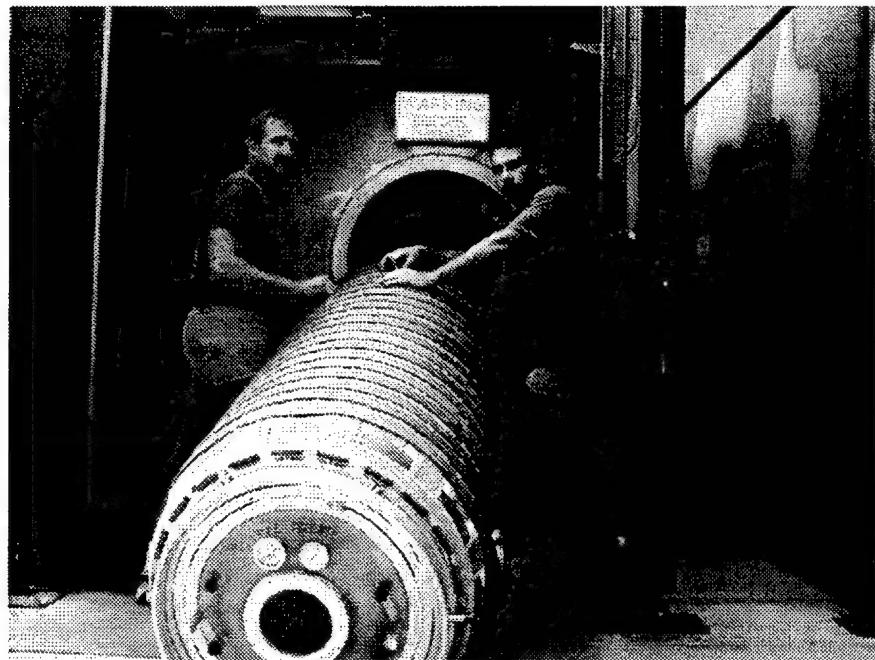
- While it was possible to load the GSE Flexible Hyperbaric into the NEDU treatment chamber, it was awkward and difficult. The extra size created difficulty in clearing the space for the hatches to swing to the closed position. The extra weight was difficult to lift over the lip of the entrance, and to position in the chamber. It was hazardous to the personnel, with a significant risk for back strain due to the awkward lifting positions necessary. It is not possible to load the GSE Flexible Hyperbaric 30-inch models (76 cm) (the unit that was tested) into a Dixie Double Lock chamber. The diameter of this EEHS is larger than the diameter of the opening to the Dixie Double Lock. Thus, for use as an evacuation device, it is not compatible with the most common receiving

ILLUSTRATION A-3. GSE FLEXIBLE HYPERBARIC WILL NOT FIT INTO STANDARD U.S. NAVY DIXIE DOUBLE-LOCK CHAMBER.

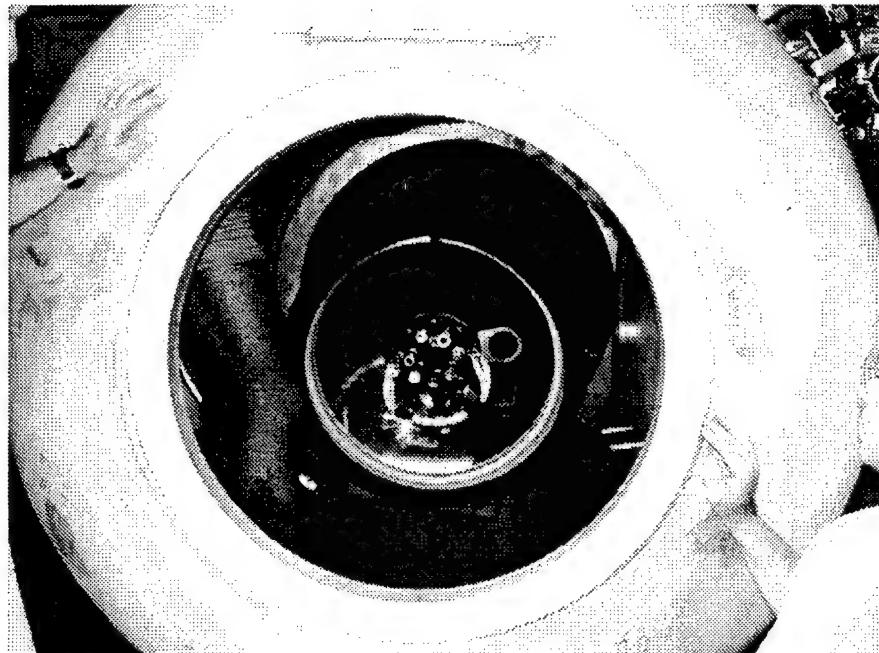
ILLUSTRATION A-4. HYPERLITE DOES FIT INTO U.S. NAVY DIXIE DOUBLE-LOCK.
